ATTACHMENT A

Photolog

Greenleaf Ledge Dairy, LLC
EPA Inspection May 9, 2019
All photos taken by Ben Atkinson, Agronomist, U.S. EPA
Camera: Ricoh WG-4 and Olympus

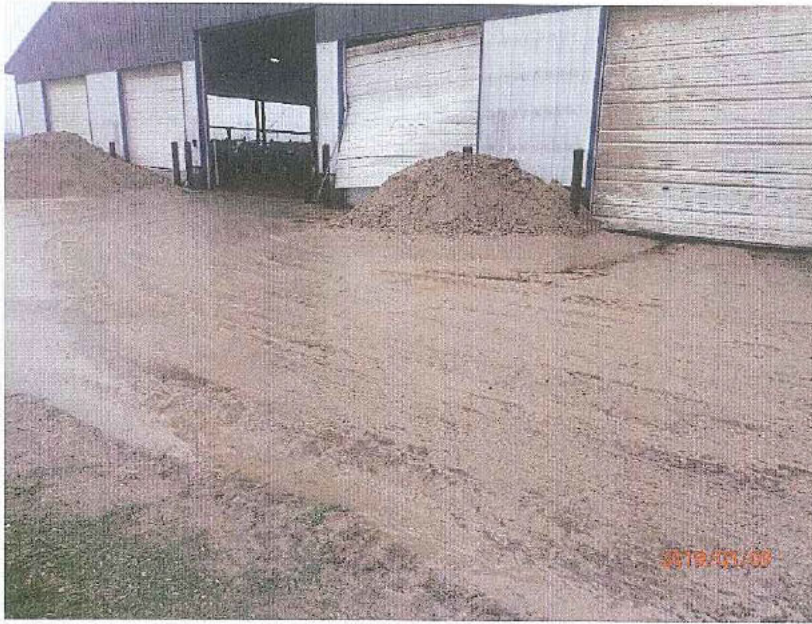
3: P5090003

Description: Close-up of process wastewater from the Old Milking Cow Barn and sediment from denuded areas around the dredged ditch discharging into the dredged ditch and flowing through the culvert inlet to the northeast under the access road.

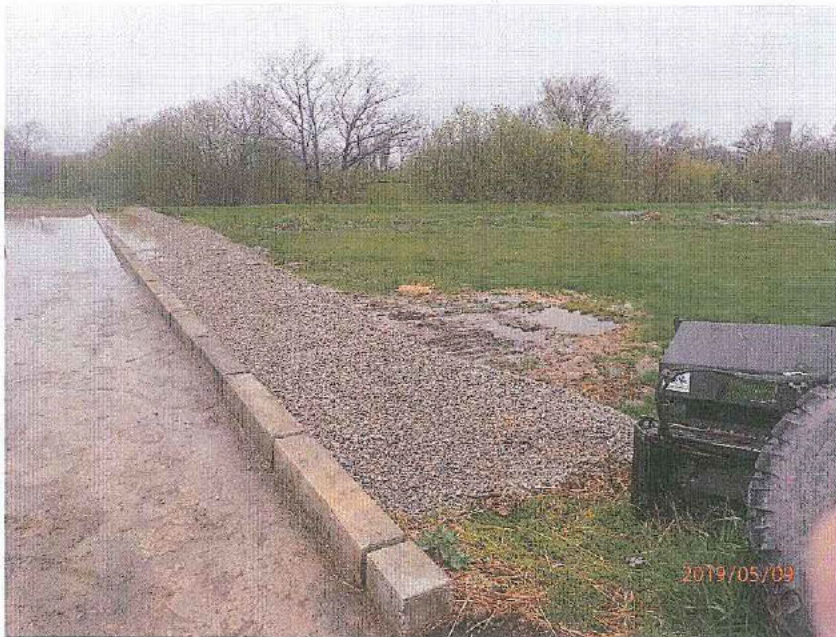
10: P5090010

Description: Spreader bar separating the silage feed pad and the vegetated treatment area.

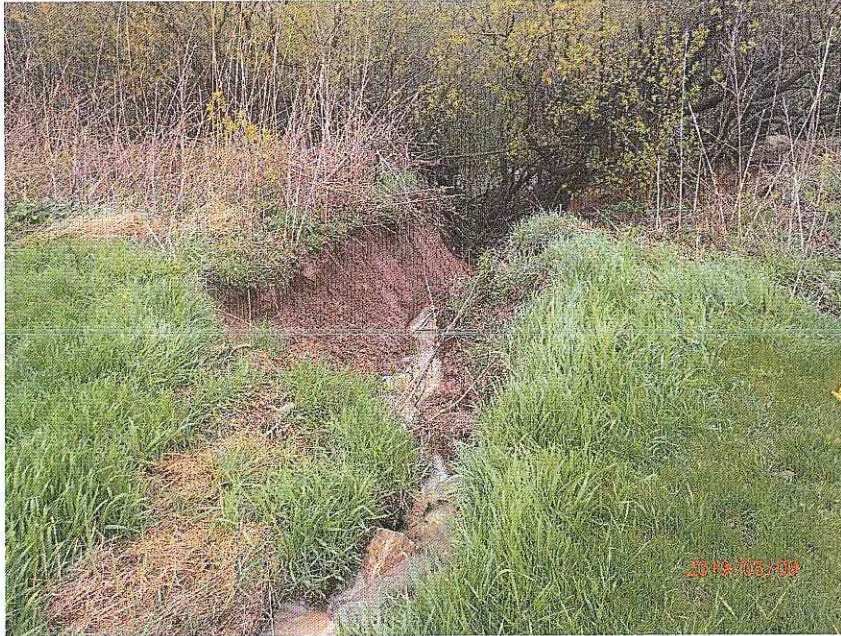
12: P5090012

Description: Northwest corner of the VTA, EPA observed that the process wastewater entering the VTA from the silage feed pad had created a channel that conveyed process wastewater to the north on the west side of the VTA and then west down the embankment and into the unnamed tributary of the East River.

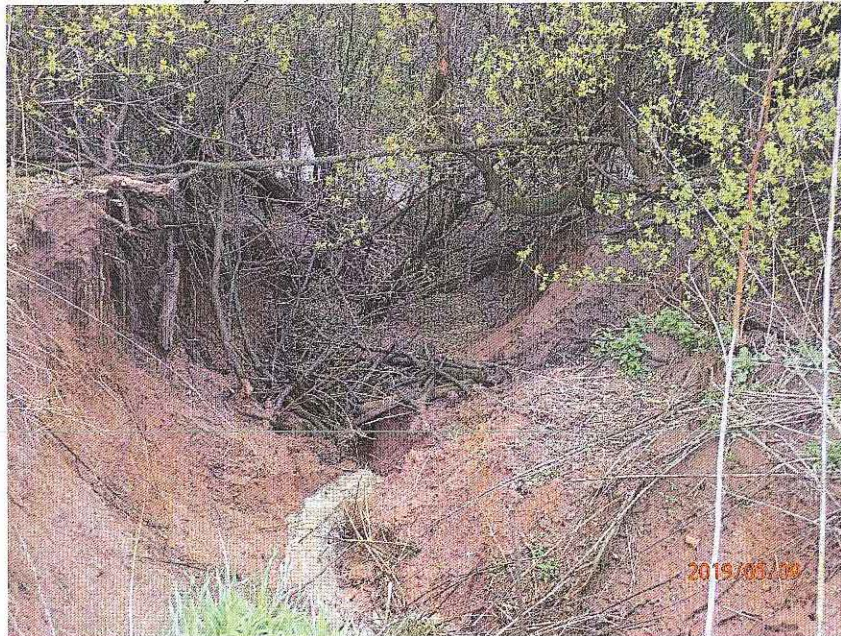
13: P5090013

Description: Eroded channel from the process wastewater that had flowed through the VTA and was discharging into the unnamed tributary of the East River.

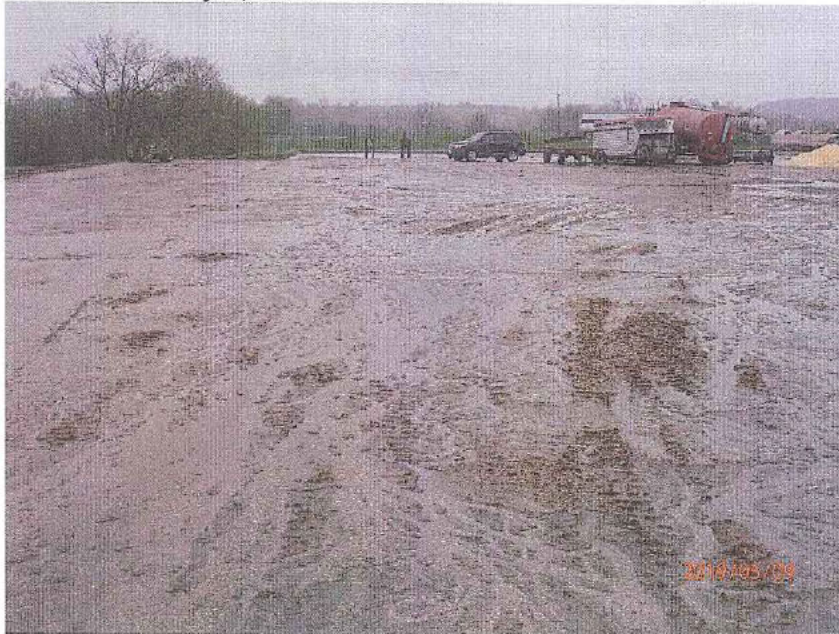
15: P5090015

Description: Northwest side of the silage feed pad, EPA observed exposed feed mixing with stormwater.

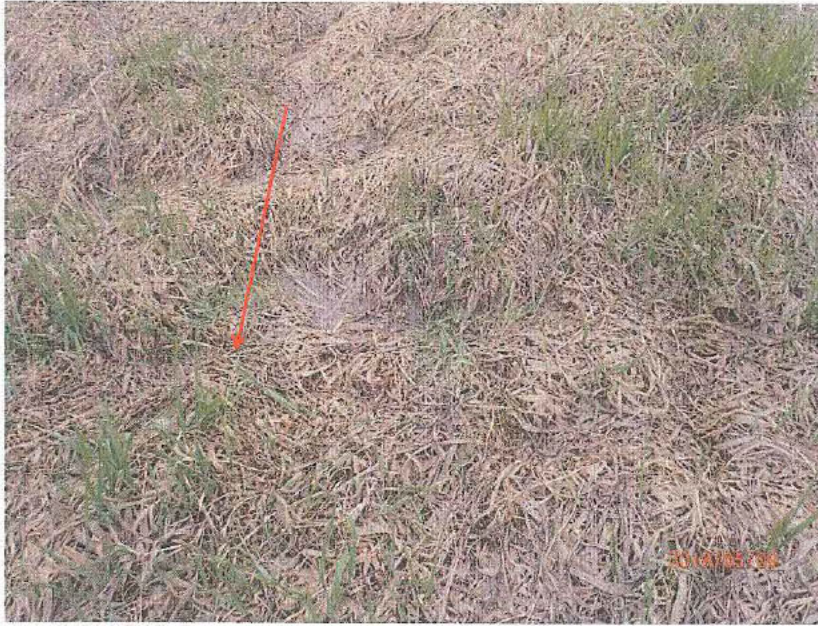
25: P5090025

Description: On the south side of Day Street, showing the flow through the grassed waterway between the alfalfa from the calf hutch area.

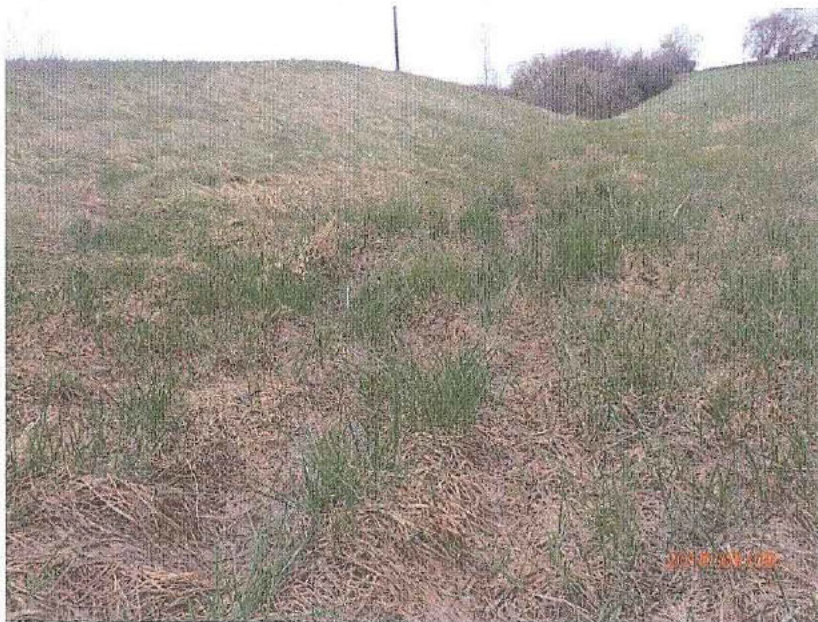
26: P5090026

Description: Close-up of the water flowing in the grassed waterway between the alfalfa.

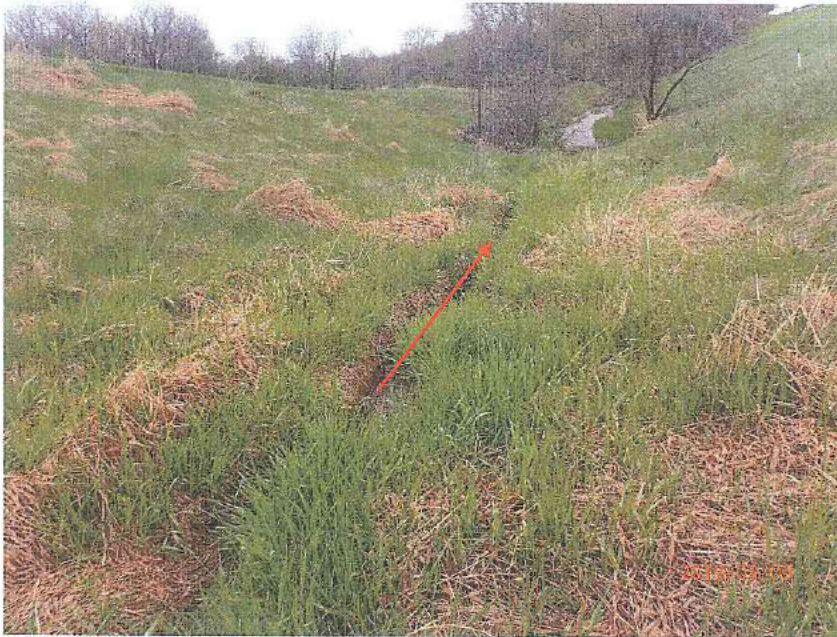
34: P5090034

Description: Flow from the roadside ditch south of Day Street channeled more deeply as it gets closer to the unnamed tributary of the East River.

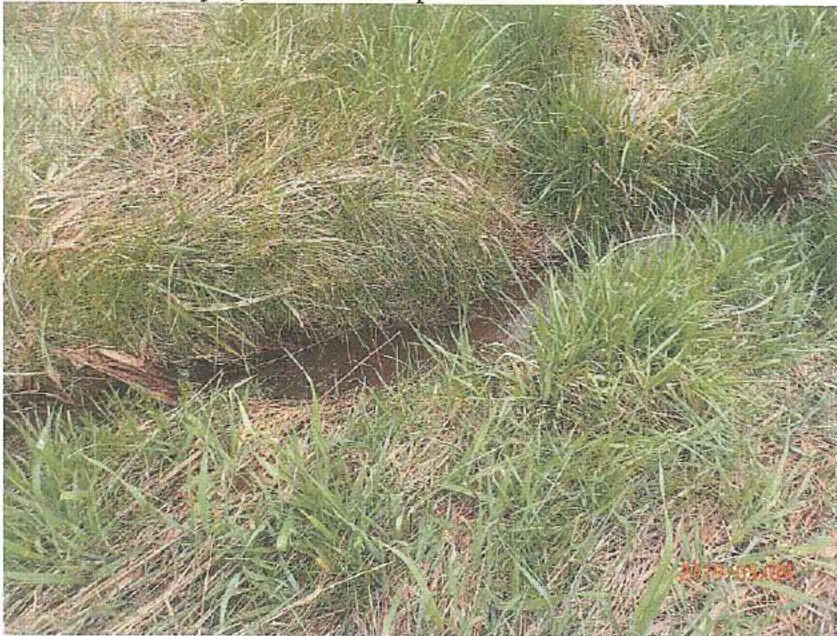
35: P5090035

Description: : Flow from the roadside ditch south of Day Street channeled more deeply as it gets closer to the unnamed tributary.

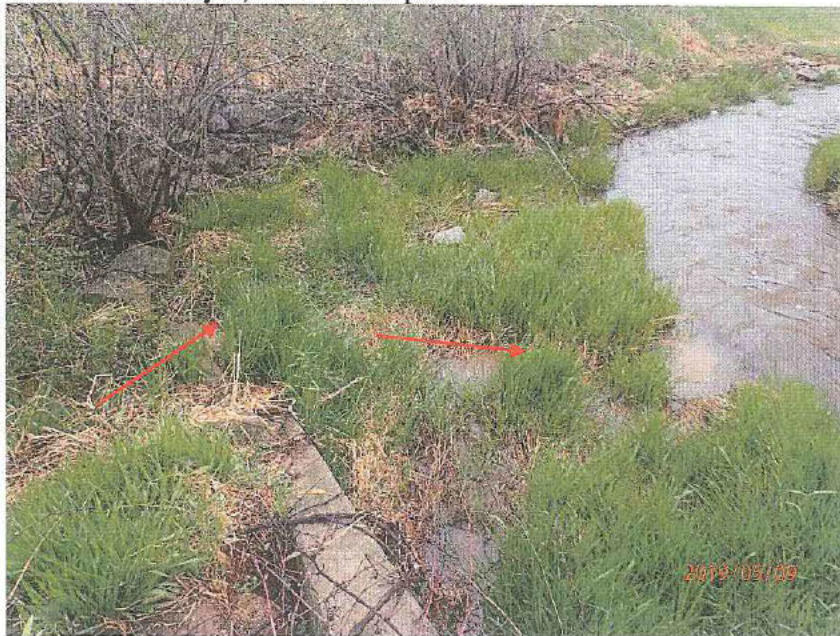
38: P5090038

Description: Flow from the roadside ditch south of Day Street channeled more deeply as it gets closer to the unnamed tributary.

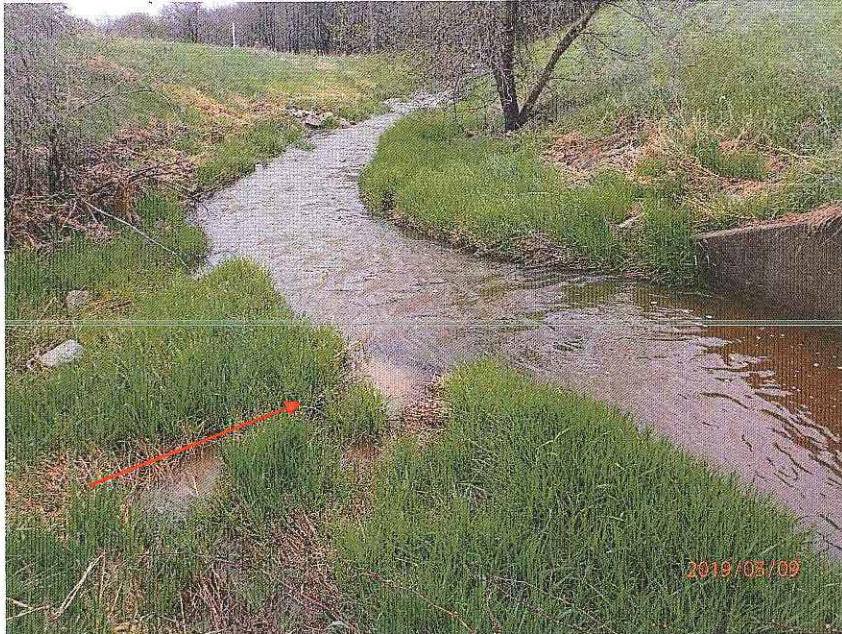
39: P5090039

Description: Roadside ditch discharging into the unnamed tributary.

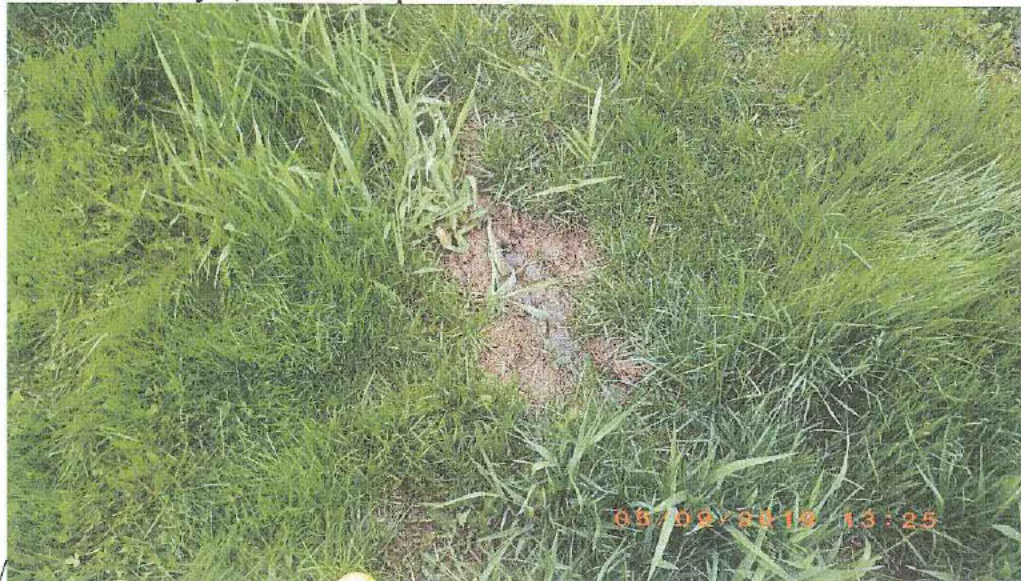
42: RIMG0092

Description: Close-up of the water flowing within the grassed waterway.

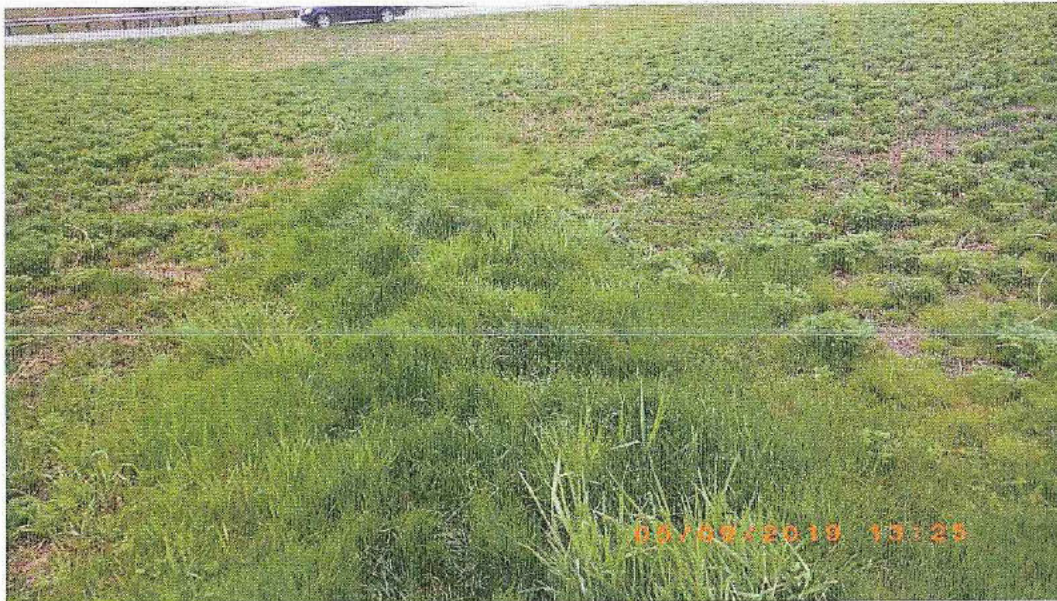
43: RIMG0093

Description: Close-up of the water flowing in the grassed waterway.

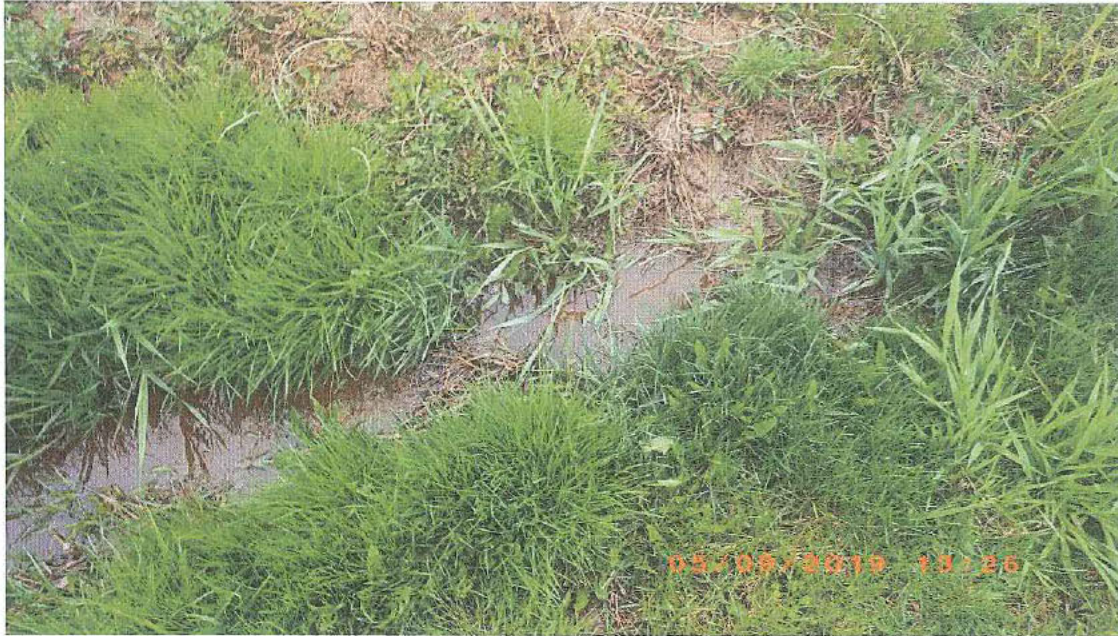
45: RIMG0095

Description: On the south side of Day Street, viewing the grassed waterway between the alfalfa that conveys the flow from the calf hutch area.

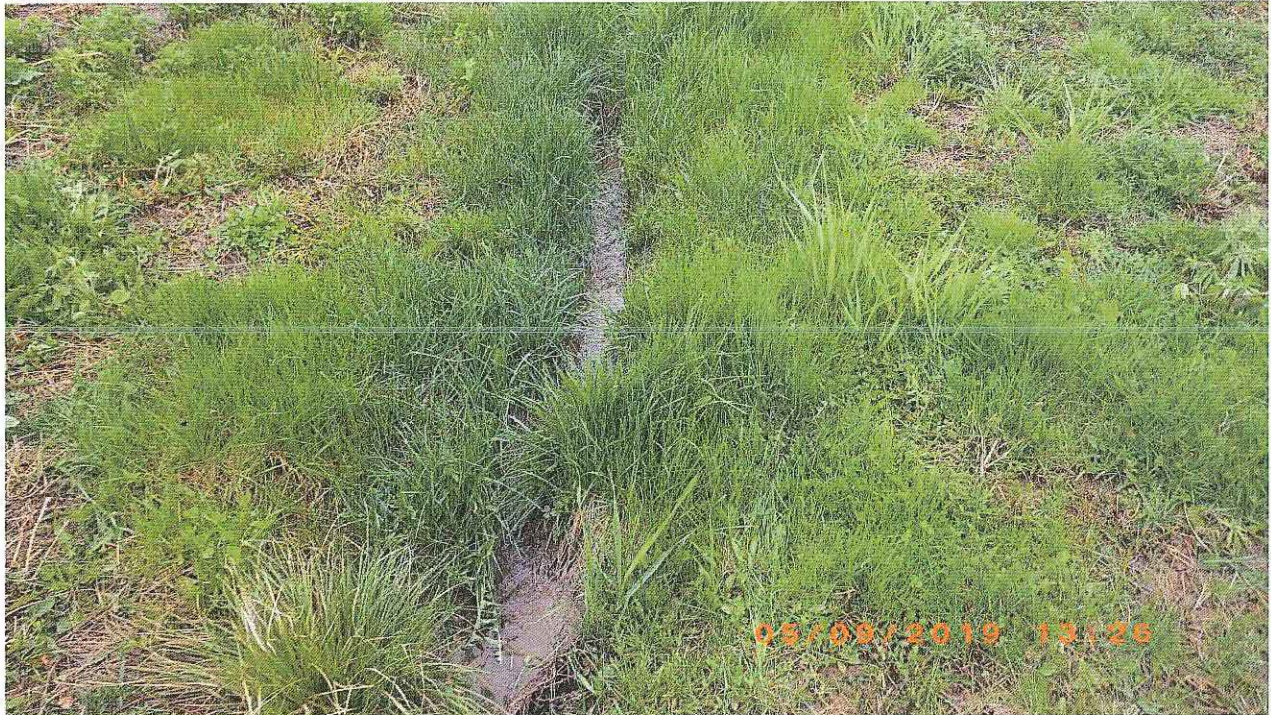
46: RIMG0096

Description: Close-up of the water flowing in the grassed waterway that came through culvert outlet and from surface flow from the calf hutch area.

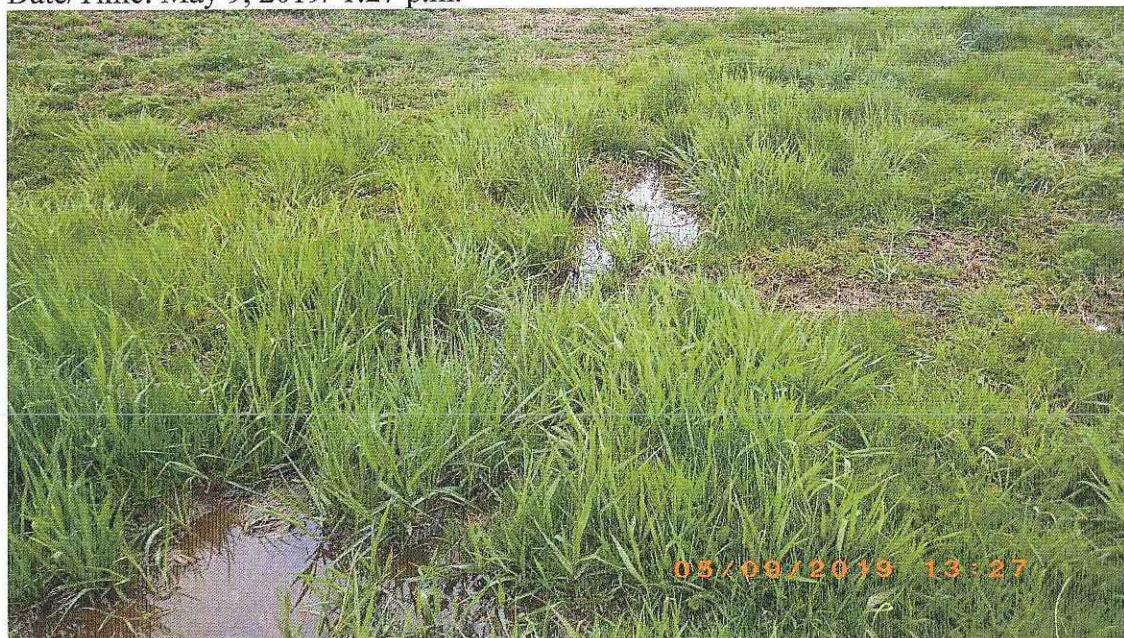
50: RIMG0100

Description: Culvert outlet that conveys the flow from the calf hutch area to the grassed waterway between the alfalfa.

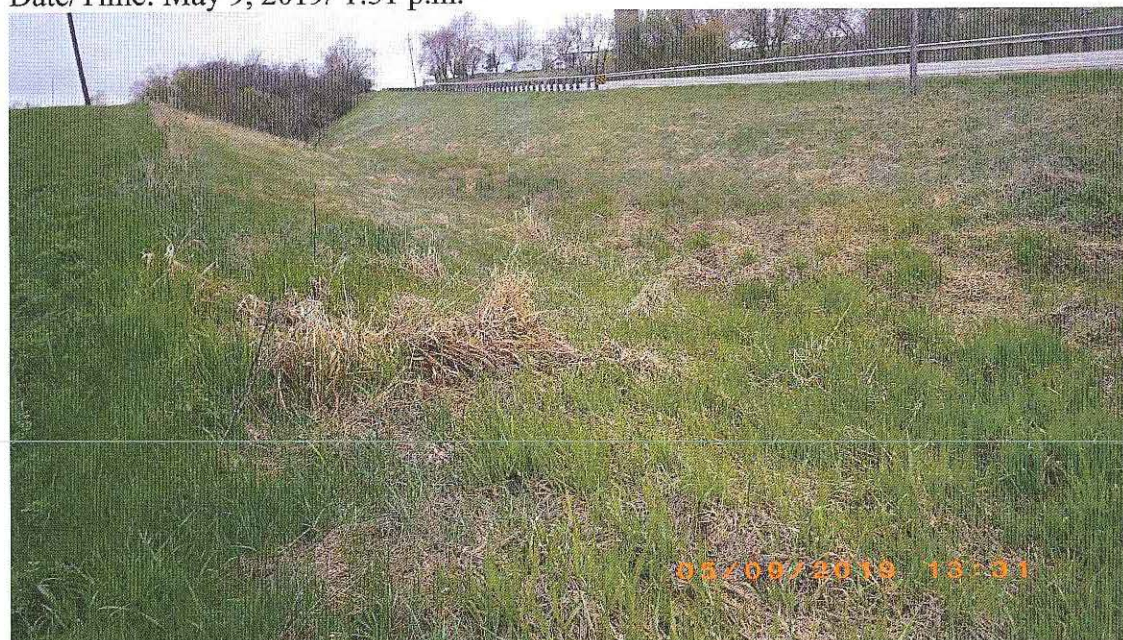
56: RIMG0106

Description: Flow from the grassed waterway flows under the dead vegetation as it flows into the roadside ditch on the south side of Day Street.

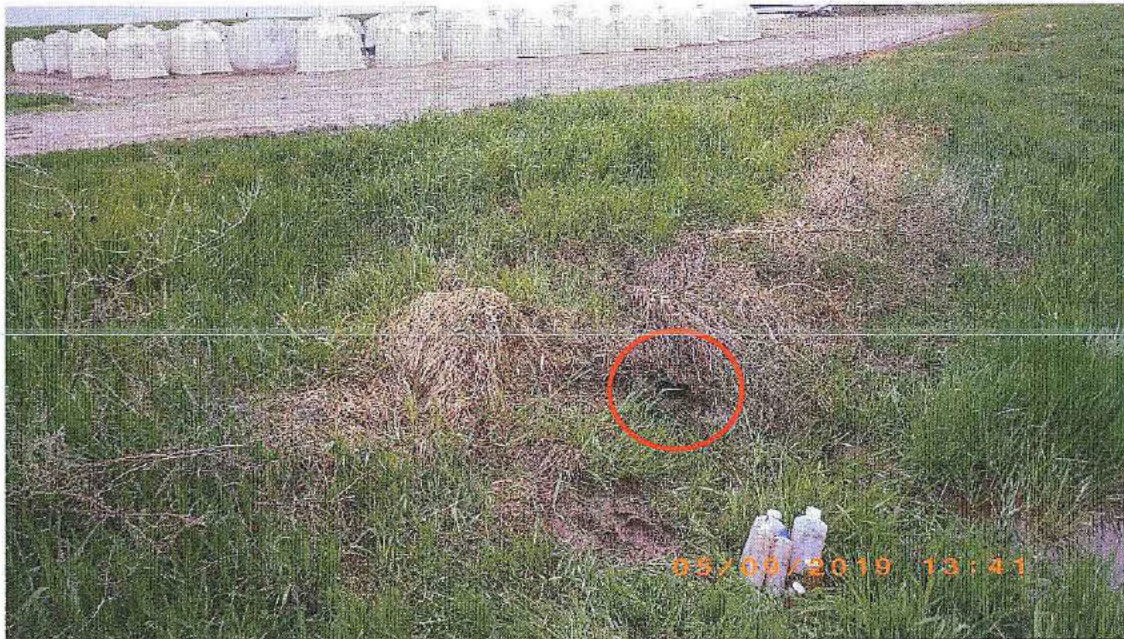
58: RIMG0108

Description: Sample S03 named "Tile Calf Hutch" was from where the surface flow from the calf hutch area and the culvert outlet combine in the grassed waterway.

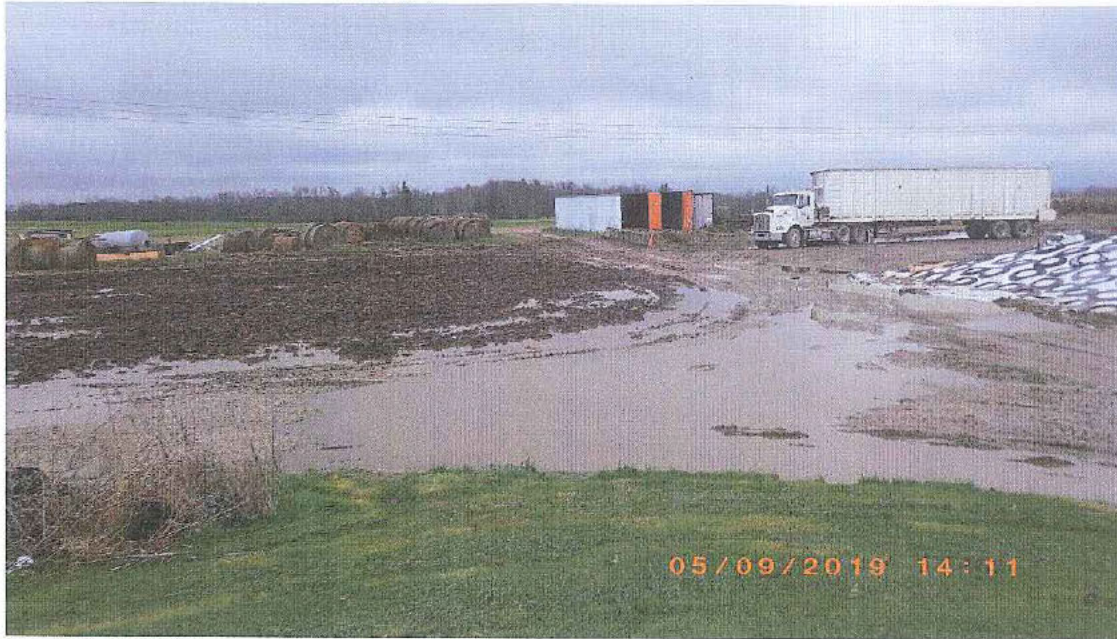
71: RIMG0121

Description: Exposed feed stored south of the New Pit.

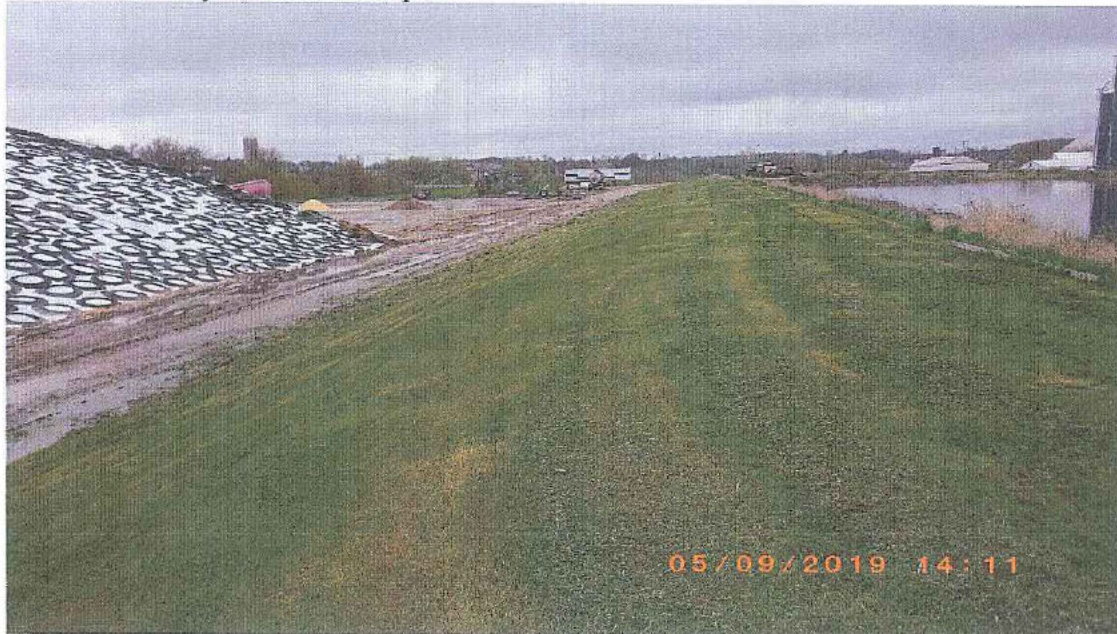
72: RIMG0122

Description: Stormwater flows on to Greenleaf's production area from the fields to south and southwest.

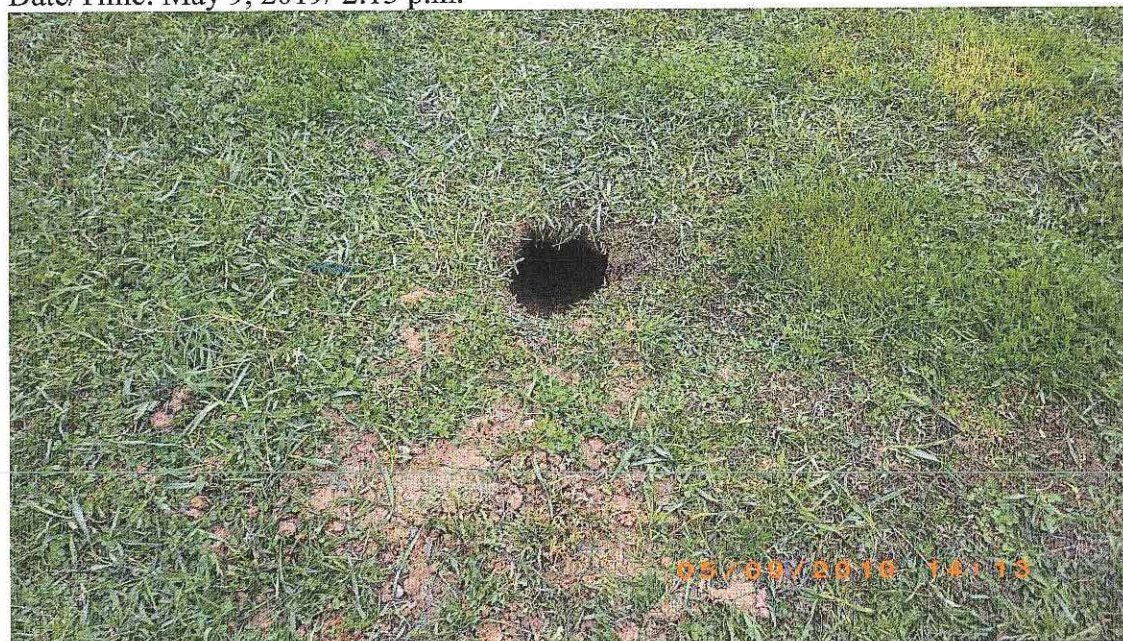
Description: EPA observed rodent holes on the west berm of the New Pit.

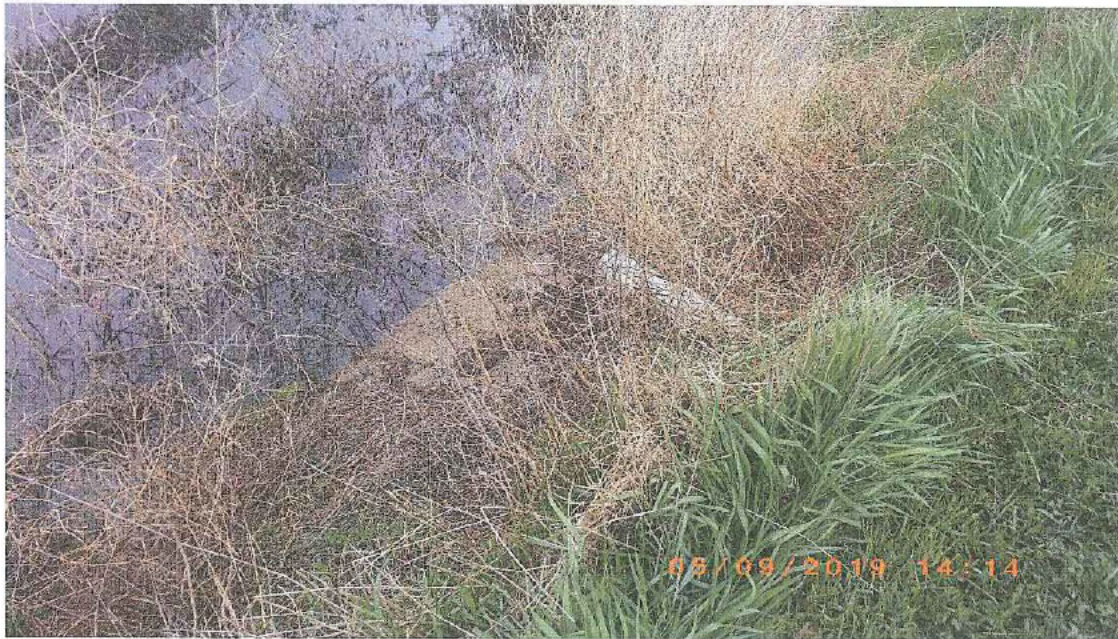
76: RIMG0126

Description: Silage feed pad outfall pipe

Location: Northwest side of the New Pit.

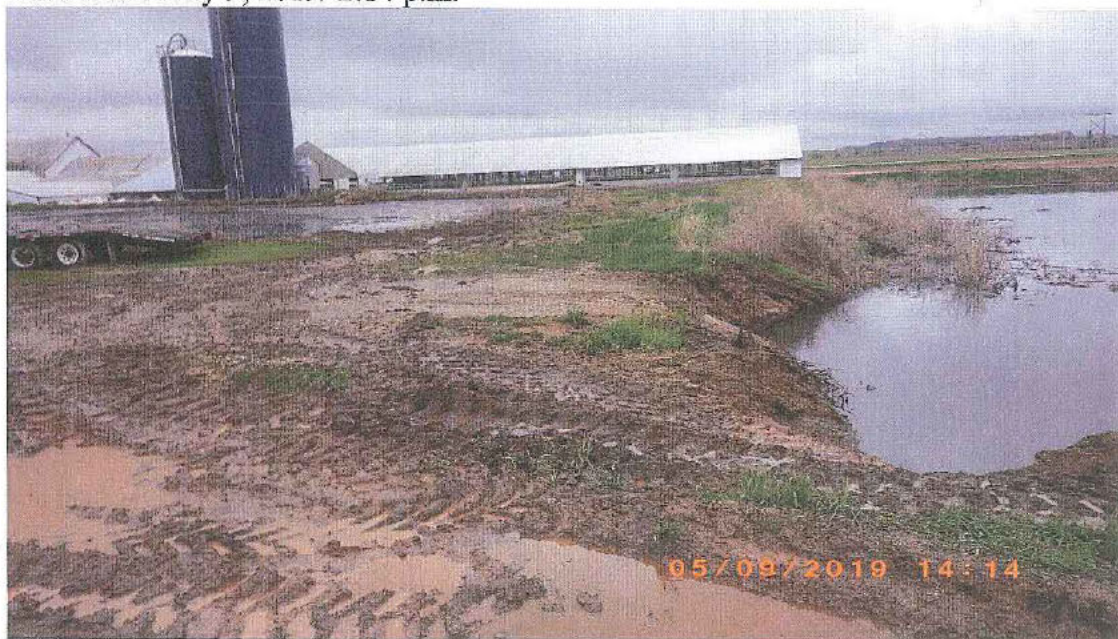
77: RIMG0127

Description: Between the New Pit and Old Pit on the west side of the pits.

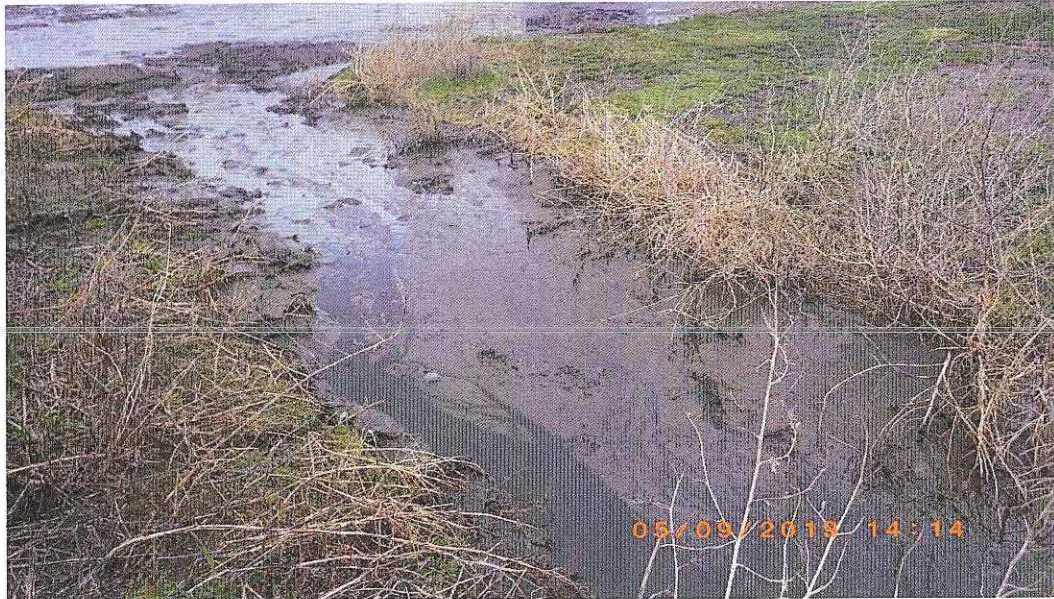
78: RIMG0128

Description: Concrete channel that conveys process wastewater from the Old Pit to the New Pit.

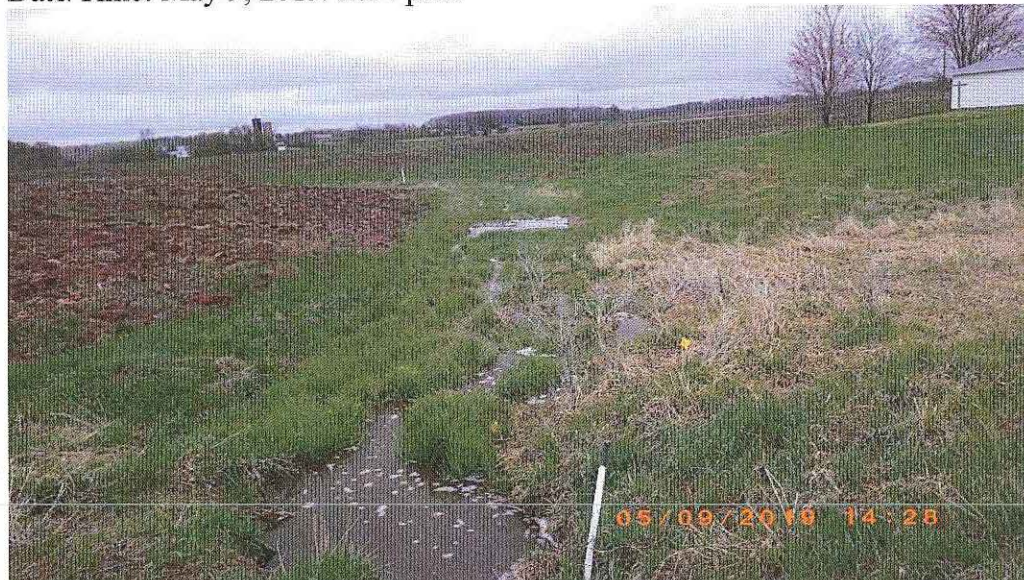
79: RIMG0129

Description: The culvert outlet from the merged channels from the residence to the east and the dredged ditch from Greenleaf's production area flowed through a culvert under Day Street to the grassed waterway on the north side of Day Street to the unnamed tributary of the East River.

Location: Culvert outlet on the north side of Day Street conveys flow from the merging of the stormwater from the east and the process wastewater from the dredged ditch on Greenleaf's production area.

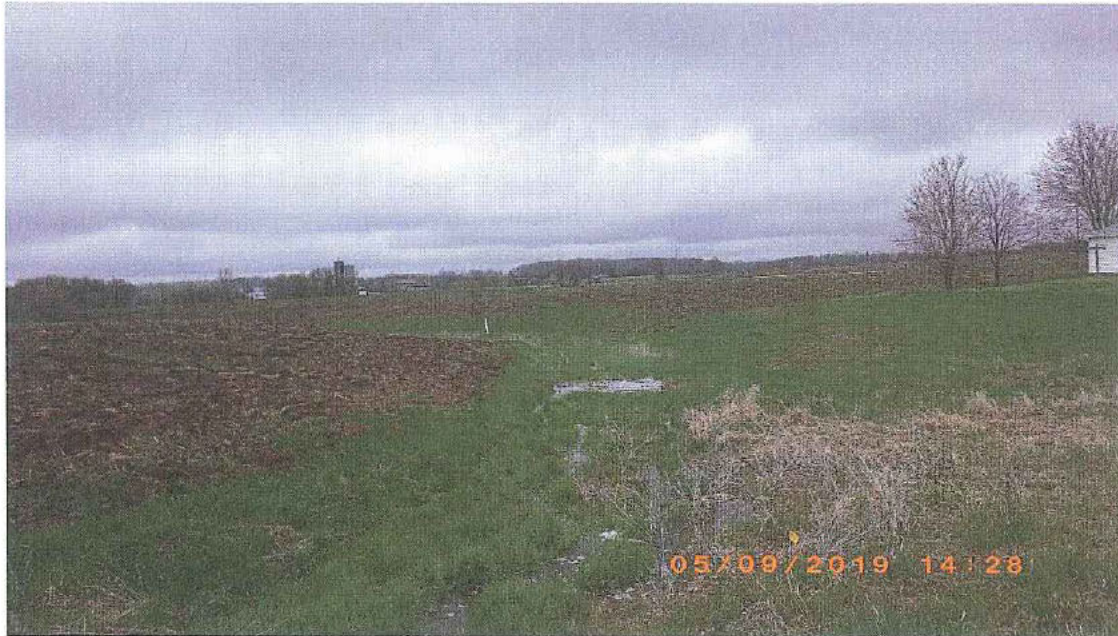
80: RIMG0130

Description: Continuation of flow from the culvert outlet that merged channels from the stormwater coming from the east and the dredged ditch from Greenleaf's production area that flowed through a culvert under Day Street to the grassed waterway on the north side of Day Street to the unnamed tributary of the East River.

Location: Culvert outlet on the north side of Day Street conveyed flow from the merging of the stormwater from the east and the process wastewater from the dredged ditch on Greenleaf's production area.
